One of the patches required in the boiler of Ab 608 – This outer shell section includes the mountings for the safety valves.

Boiler prepared to receive patch.

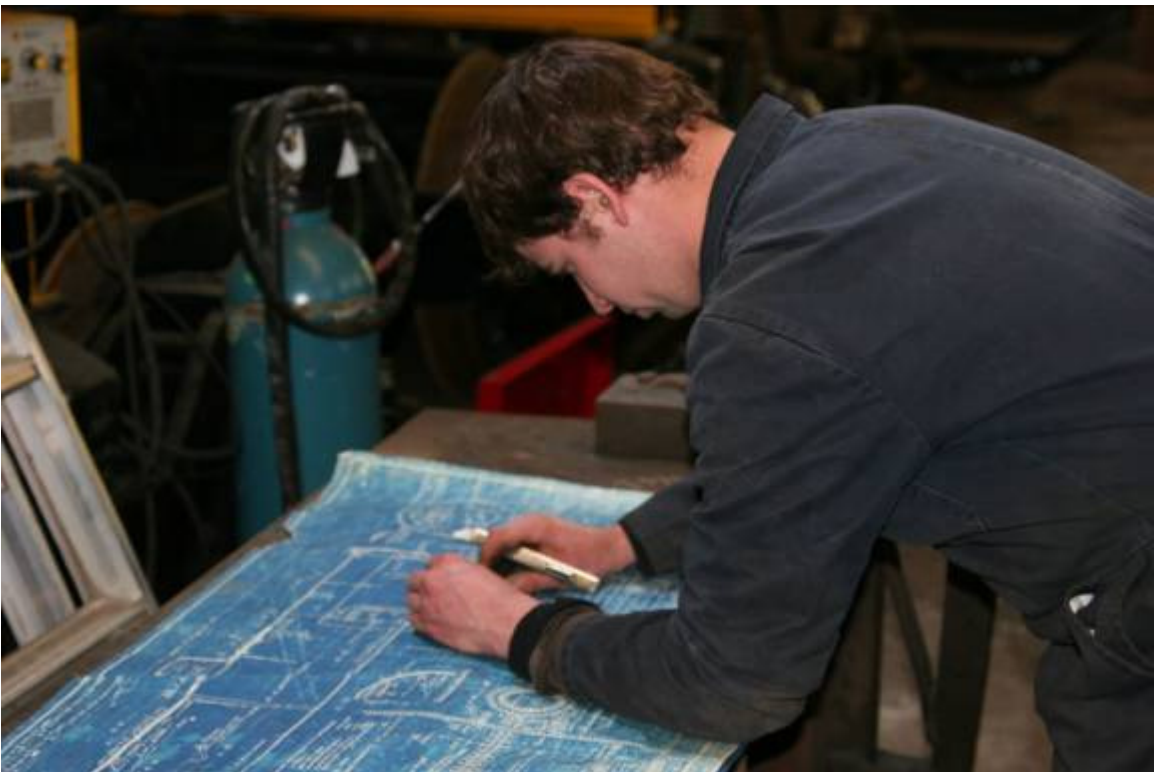
Alastair Maciver checks the Ab blueprints during preparation of the patch repair.

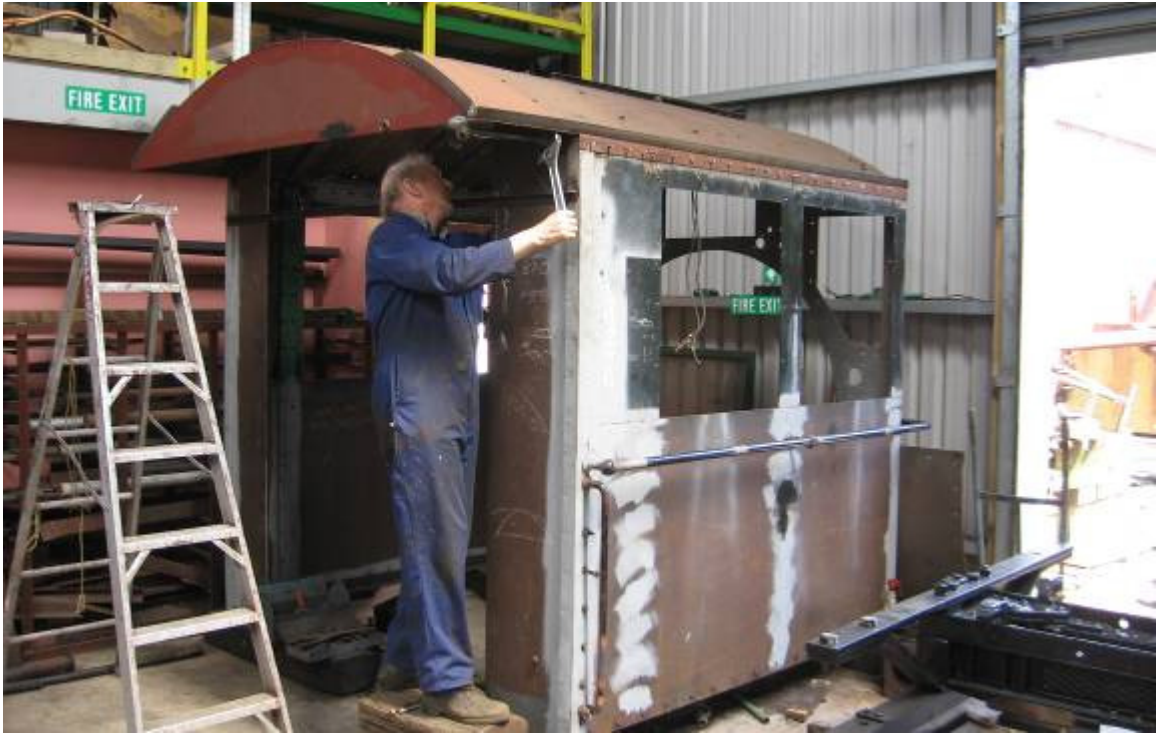
Bob Hall fits electrical conduit to the cab of Ab 608. A tender bogie frame lies alongside under repair.

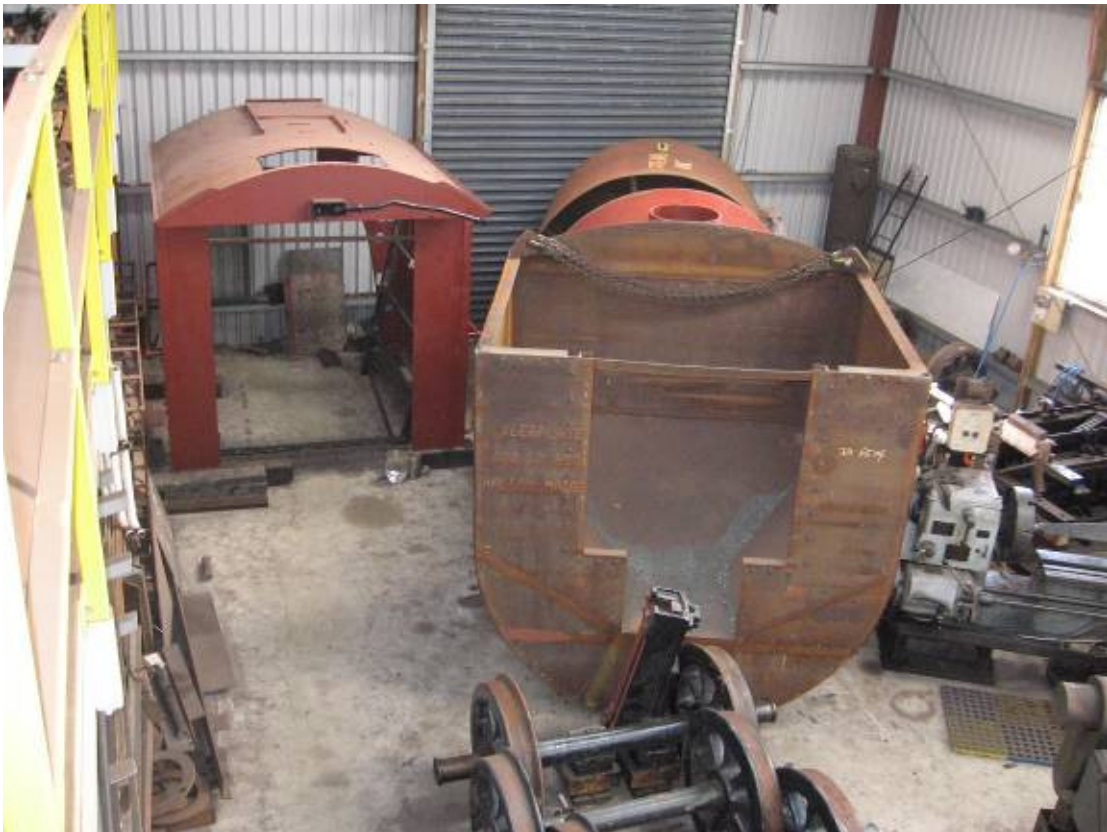
In the Steam Incorporated workshop, the near completed cab shares space with the tender body, still in two halves, about to be joined together. Tender wheelsets are gathered in the foreground.

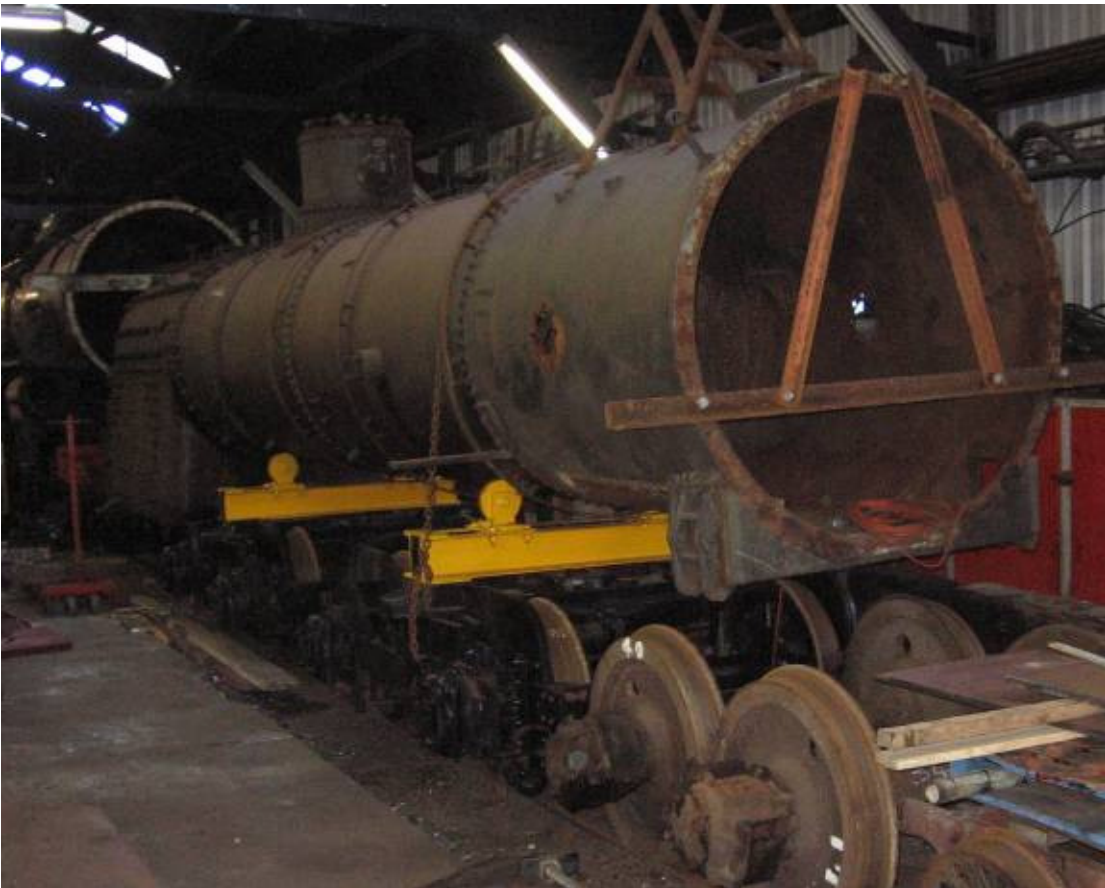
Ab 608's boiler mounted on roller-equipped accommodation bogies in preparation for major boiler repairs.
